Manhole Inspection Summary

Manhole # S09II1001MH

Location Address: **PARK OFF REISTERSTOWN RD** Cross Street: **BEEHLER AVE**

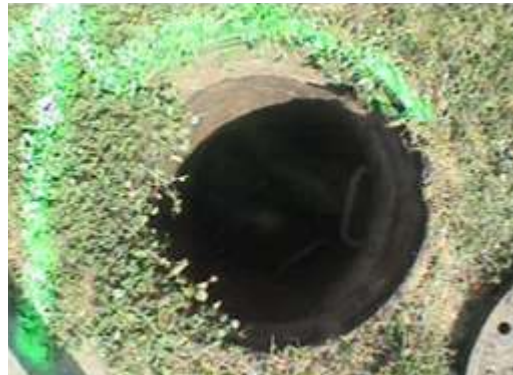
Top View

OFFSET CHANNEL

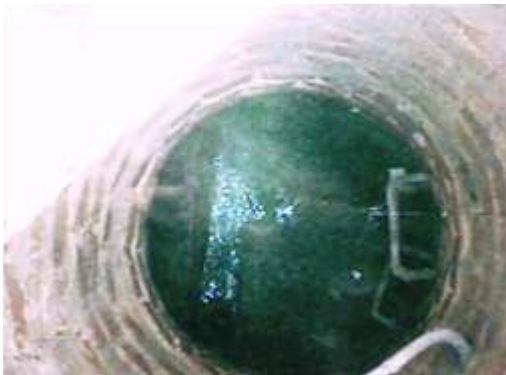
Top View

OFFSET CHANNEL

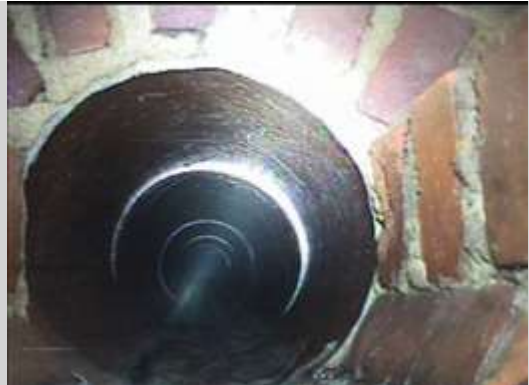
12 O'Clock Outflow

10 in. Circular Gravity Sewer
Pipe Out @ 12 O'Clock

Invert Depth: **10.19** (ft.) Flow Characteristics: **Slow**

Deposits: ☒ None ☐ Mud ☐ Sludge ☐ Debris ☐ Grease

Infiltration: **None** Pipe Seal Cond: **Sound**

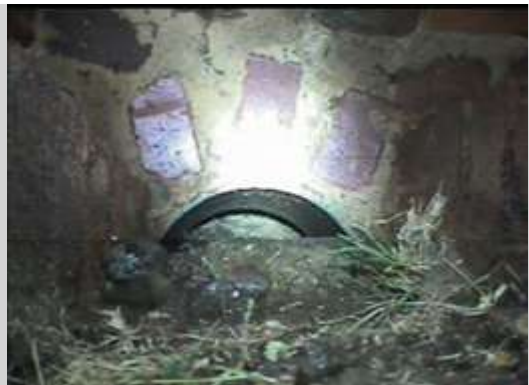
3 O'Clock Inflow

8 in. Circular Gravity Sewer
Pipe In @ 3 O'Clock

Invert Depth: **8.79** (ft.) Flow Characteristics: **None**

Deposits: ☐ None ☐ Mud ☐ Sludge ☒ **Debris** ☐ Grease

Silt Depth: **7** (in.) Deposits Extent: **Heavy**

Infiltration: **None** Pipe Seal Cond: **Sound**

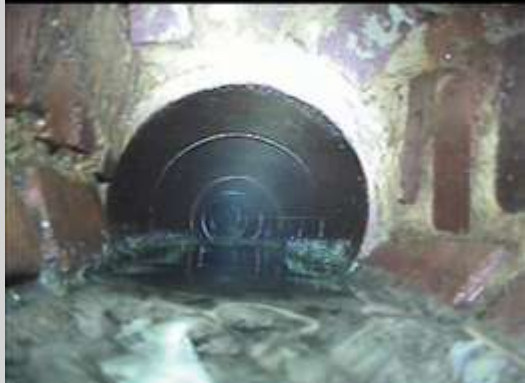
6 O'Clock Inflow

8 in. Circular Gravity Sewer
Pipe In @ 6 O'Clock

Invert Depth: **10.00** (ft.) Flow Characteristics: **Slow**

Deposits: ☒ None ☐ Mud ☐ Sludge ☐ Debris ☐ Grease

Infiltration: **None** Pipe Seal Cond: **Sound**
